Paper Machine Fan Pump Rehab

Overview

A paper mill in the southeast was experiencing extreme corrosion and erosion on the casing of a Warren 36DLB38 Pump – the heartbeat of their paper machine. A true workhorse pump with over 50 years of operation has led to corrosion and erosion that resulted in leaks and efficiency issues. Since a 2008 inspection, the casing developed holes, and the stuffing box's grooves had deteriorated making it difficult to find a successful sealing surface for new packing. The mill needed an innovative approach to avoid a costly capital equipment purchase and extended down time. During their annual outage, Southeast Pump Specialist developed and implemented a quick solution to repair the casing and stuffing box within the outage time frame.

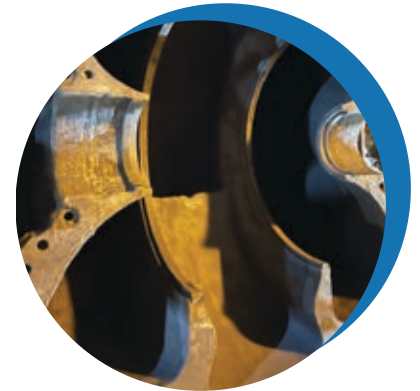
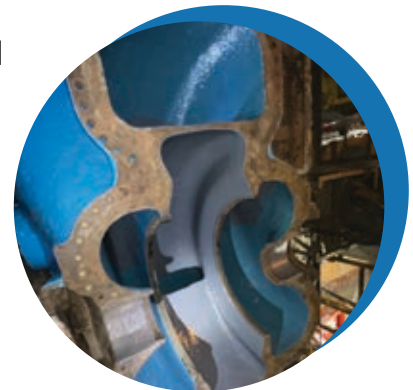
Southeast Pump suggested sandblasting the casing to bare metal and apply the A.W. Chesterton ARC 858 as a base coat to fill in the large crevices and pitting with a dual layer of S4di coating on top to ensure longer performance and wear pattern insights during future disassembly. Our Services Team set up our mobile sandblasting unit on site to sandblast both halves to bare metal to create an ideal surface for ARC coating adhesion, and they created a template from PTFE billet of the same size as the original OD of the stuffing boxes. This billet provided our team the final OD with straight edges. In addition to the casing work, we also removed the rotating element, installed new bearings in our SKF certified clean room, and balanced it to ISO G1.0. During the next outage, our customer is planning to examine the wear patterns and apply additional coating to reinforce areas with greater wear.

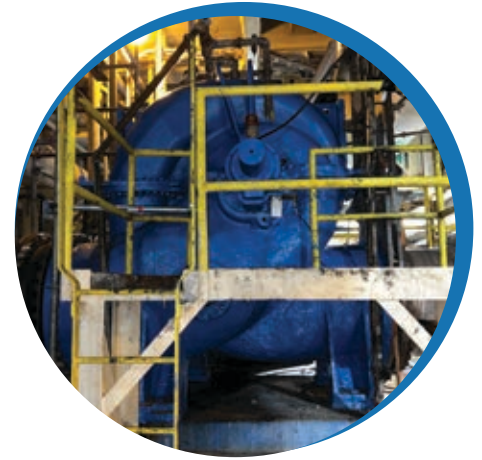
The project was completed within 10 days with the pump running perfectly without any leakage. The maintenance planner was extremely impressed with the quality and efficiency of the Southeast Pump team. The maintenance manager even went so far as to say that this project is one he is the proudest of during his time with this paper mill. The pump continues to run to this day and the leaders at the papermill are ecstatic about how well the pump is running.
